CALIFORNIA DIVISION OF MINES AND GEOLOGY

FAULT EVALUATION REPORT FER-99

SEPTEMBER 24, 1980

San Andreas and Harris Ranch faults.

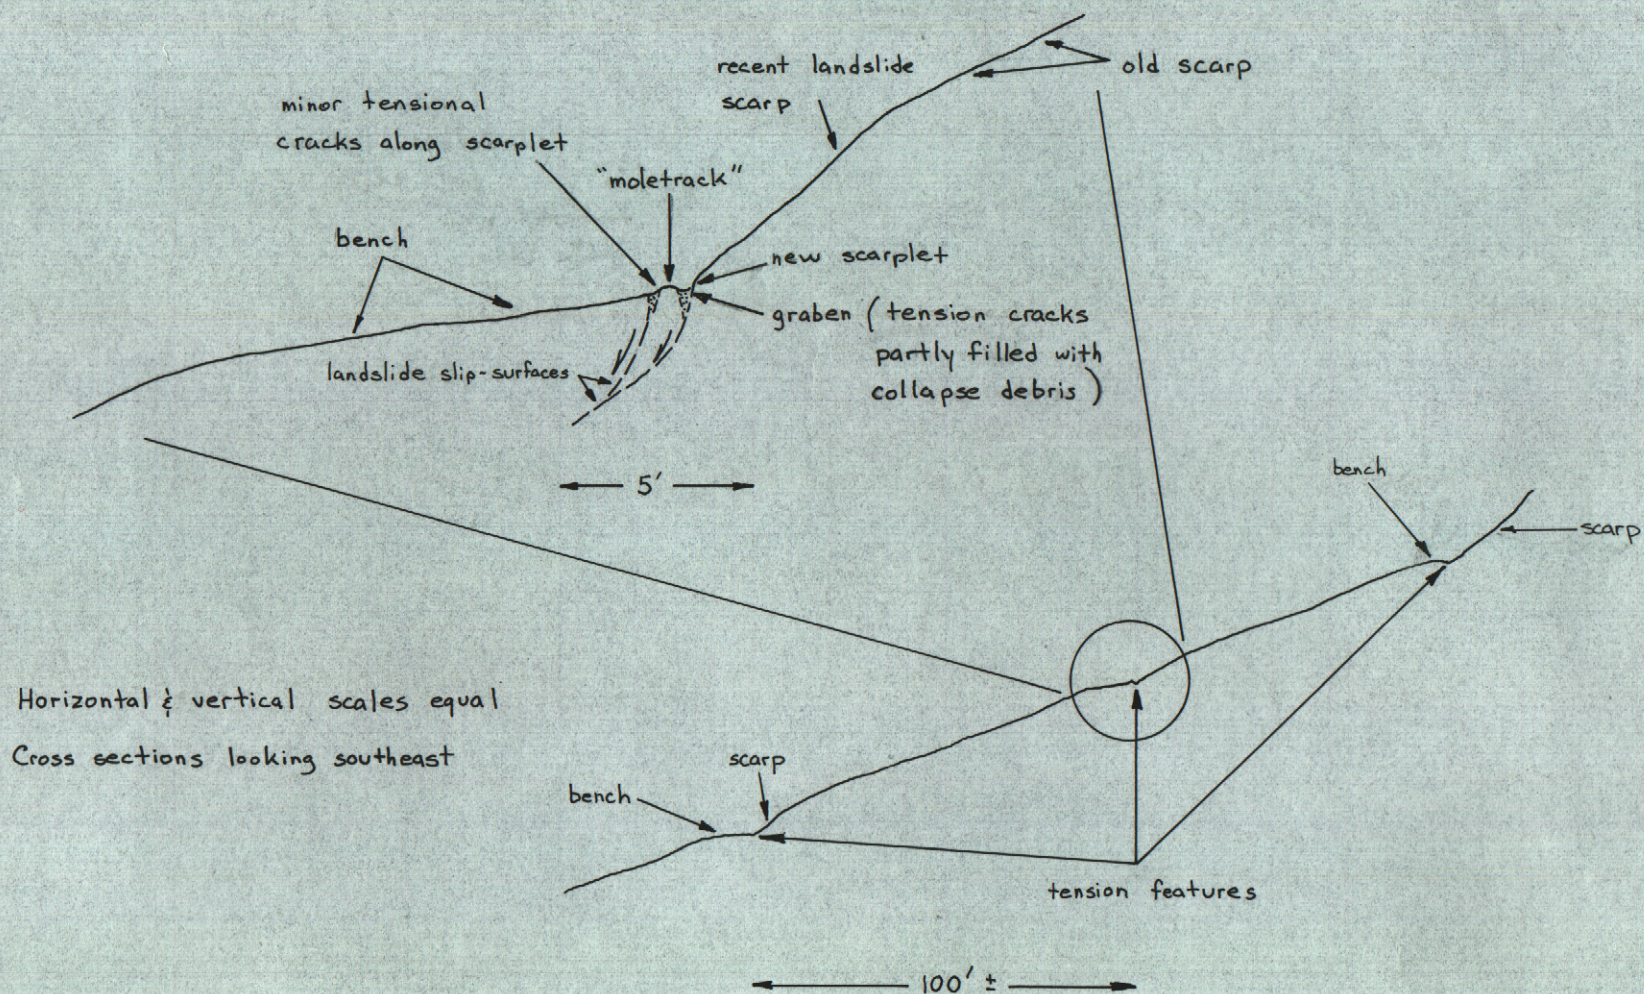
A possible explanation for the formation of a moletrack-like feature on a landslide is shown in figure 5. Two minor landslide slip surfaces and associated tension cracks form a double scarplet. These tension cracks enlarge, collapse, and erode to a moletrack-like feature (figure 5). Sinuous tension cracks in association with fresh scarplets along bench/scarp interfaces (photo 3) and slightly hummocky topography elsewhere to the north of this location further support the landslide explanation (figure 3).

trace that joins the main trace of the San Andreas fault (Smith, 1980; this report, figure 3). The moletrack observed by Rogers during field mapping in the mid-1960's is located in an area of active landsliding (figures 3, 5). A "moletrack" feature in the area reported by Rogers was observed by this writer during a field check in early May 1980. The "moletrack" was associated with a distinctive scarp-graben-bench sequence characteristic of active landsliding. It is concluded that the moletrack observed by Rogers was probably formed by landsliding rather than surface faulting.

Figure 5 (to FER-99). Diagram of scarp-graben-bench sequence observed at location where Rogers mapped moletrack feature in mid-1960's. Observation by E. Hart and author made on May 1, 1980.

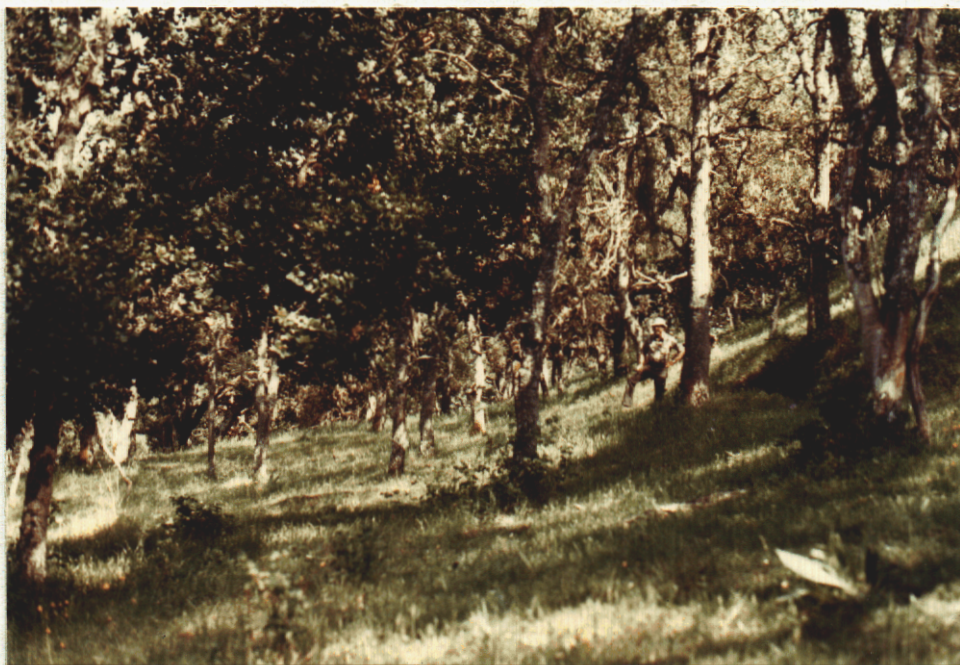
The moletrack observed by Rogers is critical in establishing the recency of movement along this fault trace. A field check of the area of Rogers' moletrack was made in early May 1980, although it was doubtful the feature would have been preserved over the intervening 15± years. The moletrack shown by Rogers is located along the base of a steep scarp that can be demonstrated to be part of an active landslide feature (figures 3, 5).

Photo 2 (to FER 99). Scarp-graben-bench sequence characteristic of the location of Rogers' moletrack; view looking southeast. Scarp is in the right part of the photo and the bench occupies the center and left part of the photo. The graben is situated at the base of the scarp where the observer is standing. Two additional sets of scarp-graben-bench features occur downslope (left) of this location (see figure 5).

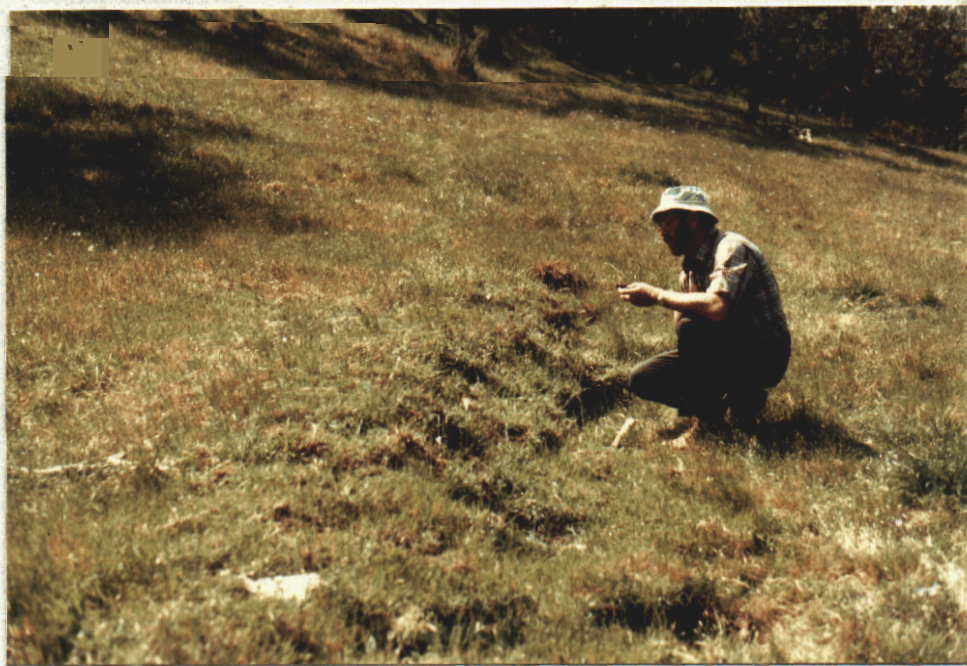
A sinuous "moletrack" about 30 to 40 feet long was observed during the field check (photo 1), and was on the location and trend of Rogers' trace of the Harris Ranch fault. The "moletrack" was very fresh and coincided with a scarplet with a vertical displacement of about 6 to 8 inches, northeast side down. Pull-apart fissures occurred along both sides of the "moletrack". The "moletrack" was located on the middle scarp/bench interface of a sequence of three scarp-graben-bench features (figure 5, photos 1, 2). Fresh pull-apart fissures adjacent to the "moletrack" and coincidence of the "moletrack" with the interface of a scarp and bench indicate that landsliding is the cause of all these features.

The relatively ephemeral nature of the "moletrac " and open fissures (grabens) indicate that downslope movement had occurred at this location within a few months prior to the field check. Heavy rains during the late winter months no doubt caused the renewed downhill movement.

Similar landslide features (scarp and bench) can be observed on 1966 WRD air photos 1727 and 1728 (USGS), suggesting that downslope movement may be an on-going process (figure 3). Since geomorphic evidence of recent faulting cannot be found along the Harris Ranch fault trace northwest and southeast of this location, it is concluded that the moletrac observed by Rogers in the mid-1960's is related to landsliding rather than faulting.

Photo 1 (to FER 99). A sinuous "moletrack" feature observed during a field check, May 1980; view looking northwest. The feature was in the same general location as the moletrack observed by Rogers in the mid-1960's. The "moletrack" in the photo does not extend more than about 10 feet beyond the observer.

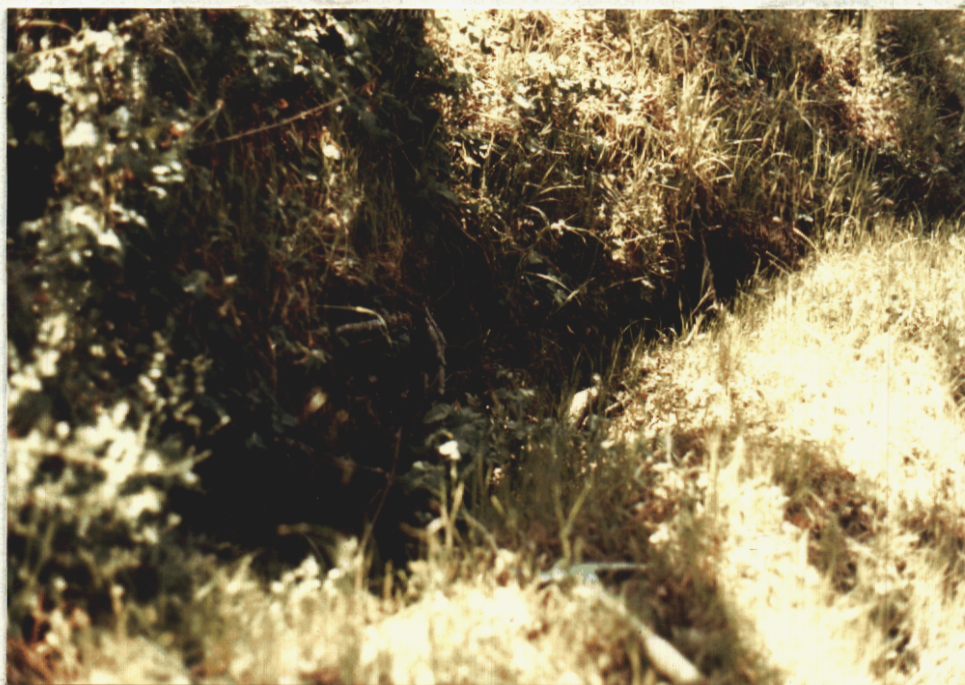
Photo 3 (to FER 99). Close-up of pull-apart graben located in vicinity of "moletrack" feature (see photo 1). The graben is located at the base of a scarp that is associated with landsliding.
